PERRY CITY DAM NO. 2
RALLS COUNTY, MISSOURI
MO. 10980

PHASE I INSPECTION REPORT
NATIONAL DAM SAFETY PROGRAM

Name of Dam: Perry City Dam No. 2, Missouri Inv. No. 10980
State Located: Missouri
County Located: Ralls
Stream: Mace Branch of Lick Creek
Date of Inspection: July 12, 1980

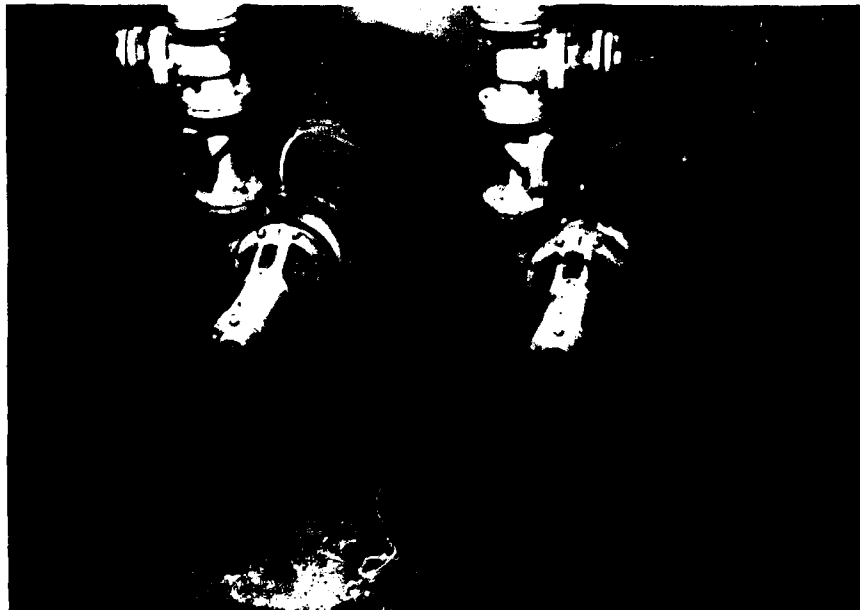
- Photo 10 - View of the two pumps located in the water treatment plant used to pump water out of the reservoir.
- Photo 11 - View of the siltstone outcrop in the downstream channel of the downstream dam.
- Photo 12 - View of the reservoir and rim.
- Photo 13 - View of a dwelling downstream of the dam which appears to be in the downstream hazard zone.
- Photo 14 - View of a dwelling downstream of the dam which appears to be in the downstream hazard zone.
